Contract #: 04-0120F4Cty: SF/ALA Rte: 80 PM: 13.2/13.9File #: 1.28**WELDING INSPECTION REPORT****Resident Engineer:**Pursell, Gary**Address:** 333 Burma Road**City:** Oakland, CA 94607**Report No:** WIR-012811**Date Inspected:** 26-Mar-2010**Project Name:** SAS Superstructure**OSM Arrival Time:** 630**Prime Contractor:** American Bridge/Fluor Enterprises, a JV**OSM Departure Time:** 1500**Contractor:** American Bridge/Fluor Enterprises, a JV**Location:** Job Site

CWI Name:	Bernard Docena, Jesse Cayabayab			CWI Presenting:	Yes	No	
Inspected CWI report:	Yes	No	N/A	Rod Oven in Use:	Yes	No	N/A
Electrode to specification:	Yes	No	N/A	Weld Procedures Followed:	Yes	No	N/A
Qualified Welders:	Yes	No	N/A	Verified Joint Fit-up:	Yes	No	N/A
Approved Drawings:	Yes	No	N/A	Approved WPS:	Yes	No	N/A
				Delayed / Cancelled:	Yes	No	N/A
Bridge No:	34-0006			Component:	SAS OBG 2E/3E-A,F

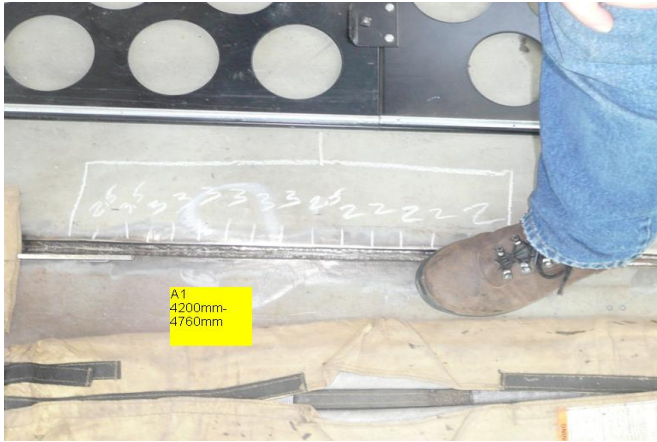
3E/4E-A1

2mm-3.5mm of misalignment beginning at 4200mm-4760mm (length 560mm).(pictured below)

The QA Inspector noted the readings identified above begin with the most significant off set or misalignment and

gradually slope toward the smallest off set or misalignment. The QA Inspector noted an incident report was generated for the unacceptable fit up due to planar misalignment.

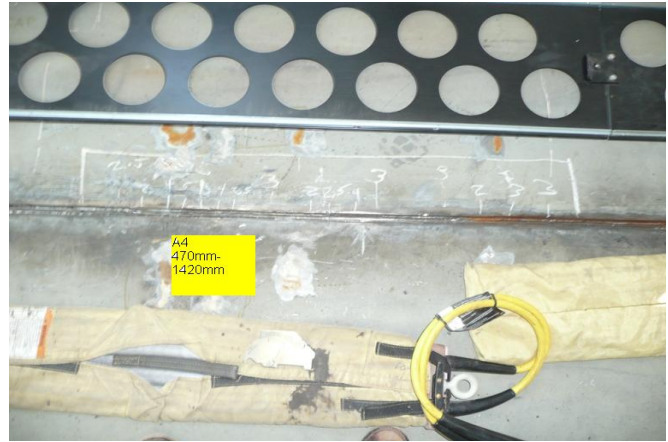
3E/4E-A4

6mm-2mm of misalignment beginning at 470mm-1420mm (length 950mm).(pictured below)
